Estate Management Plan

**Kingsmeadows Peebles,
Scottish Borders**

DWA Landscape Architects Ltd

Granton Homes

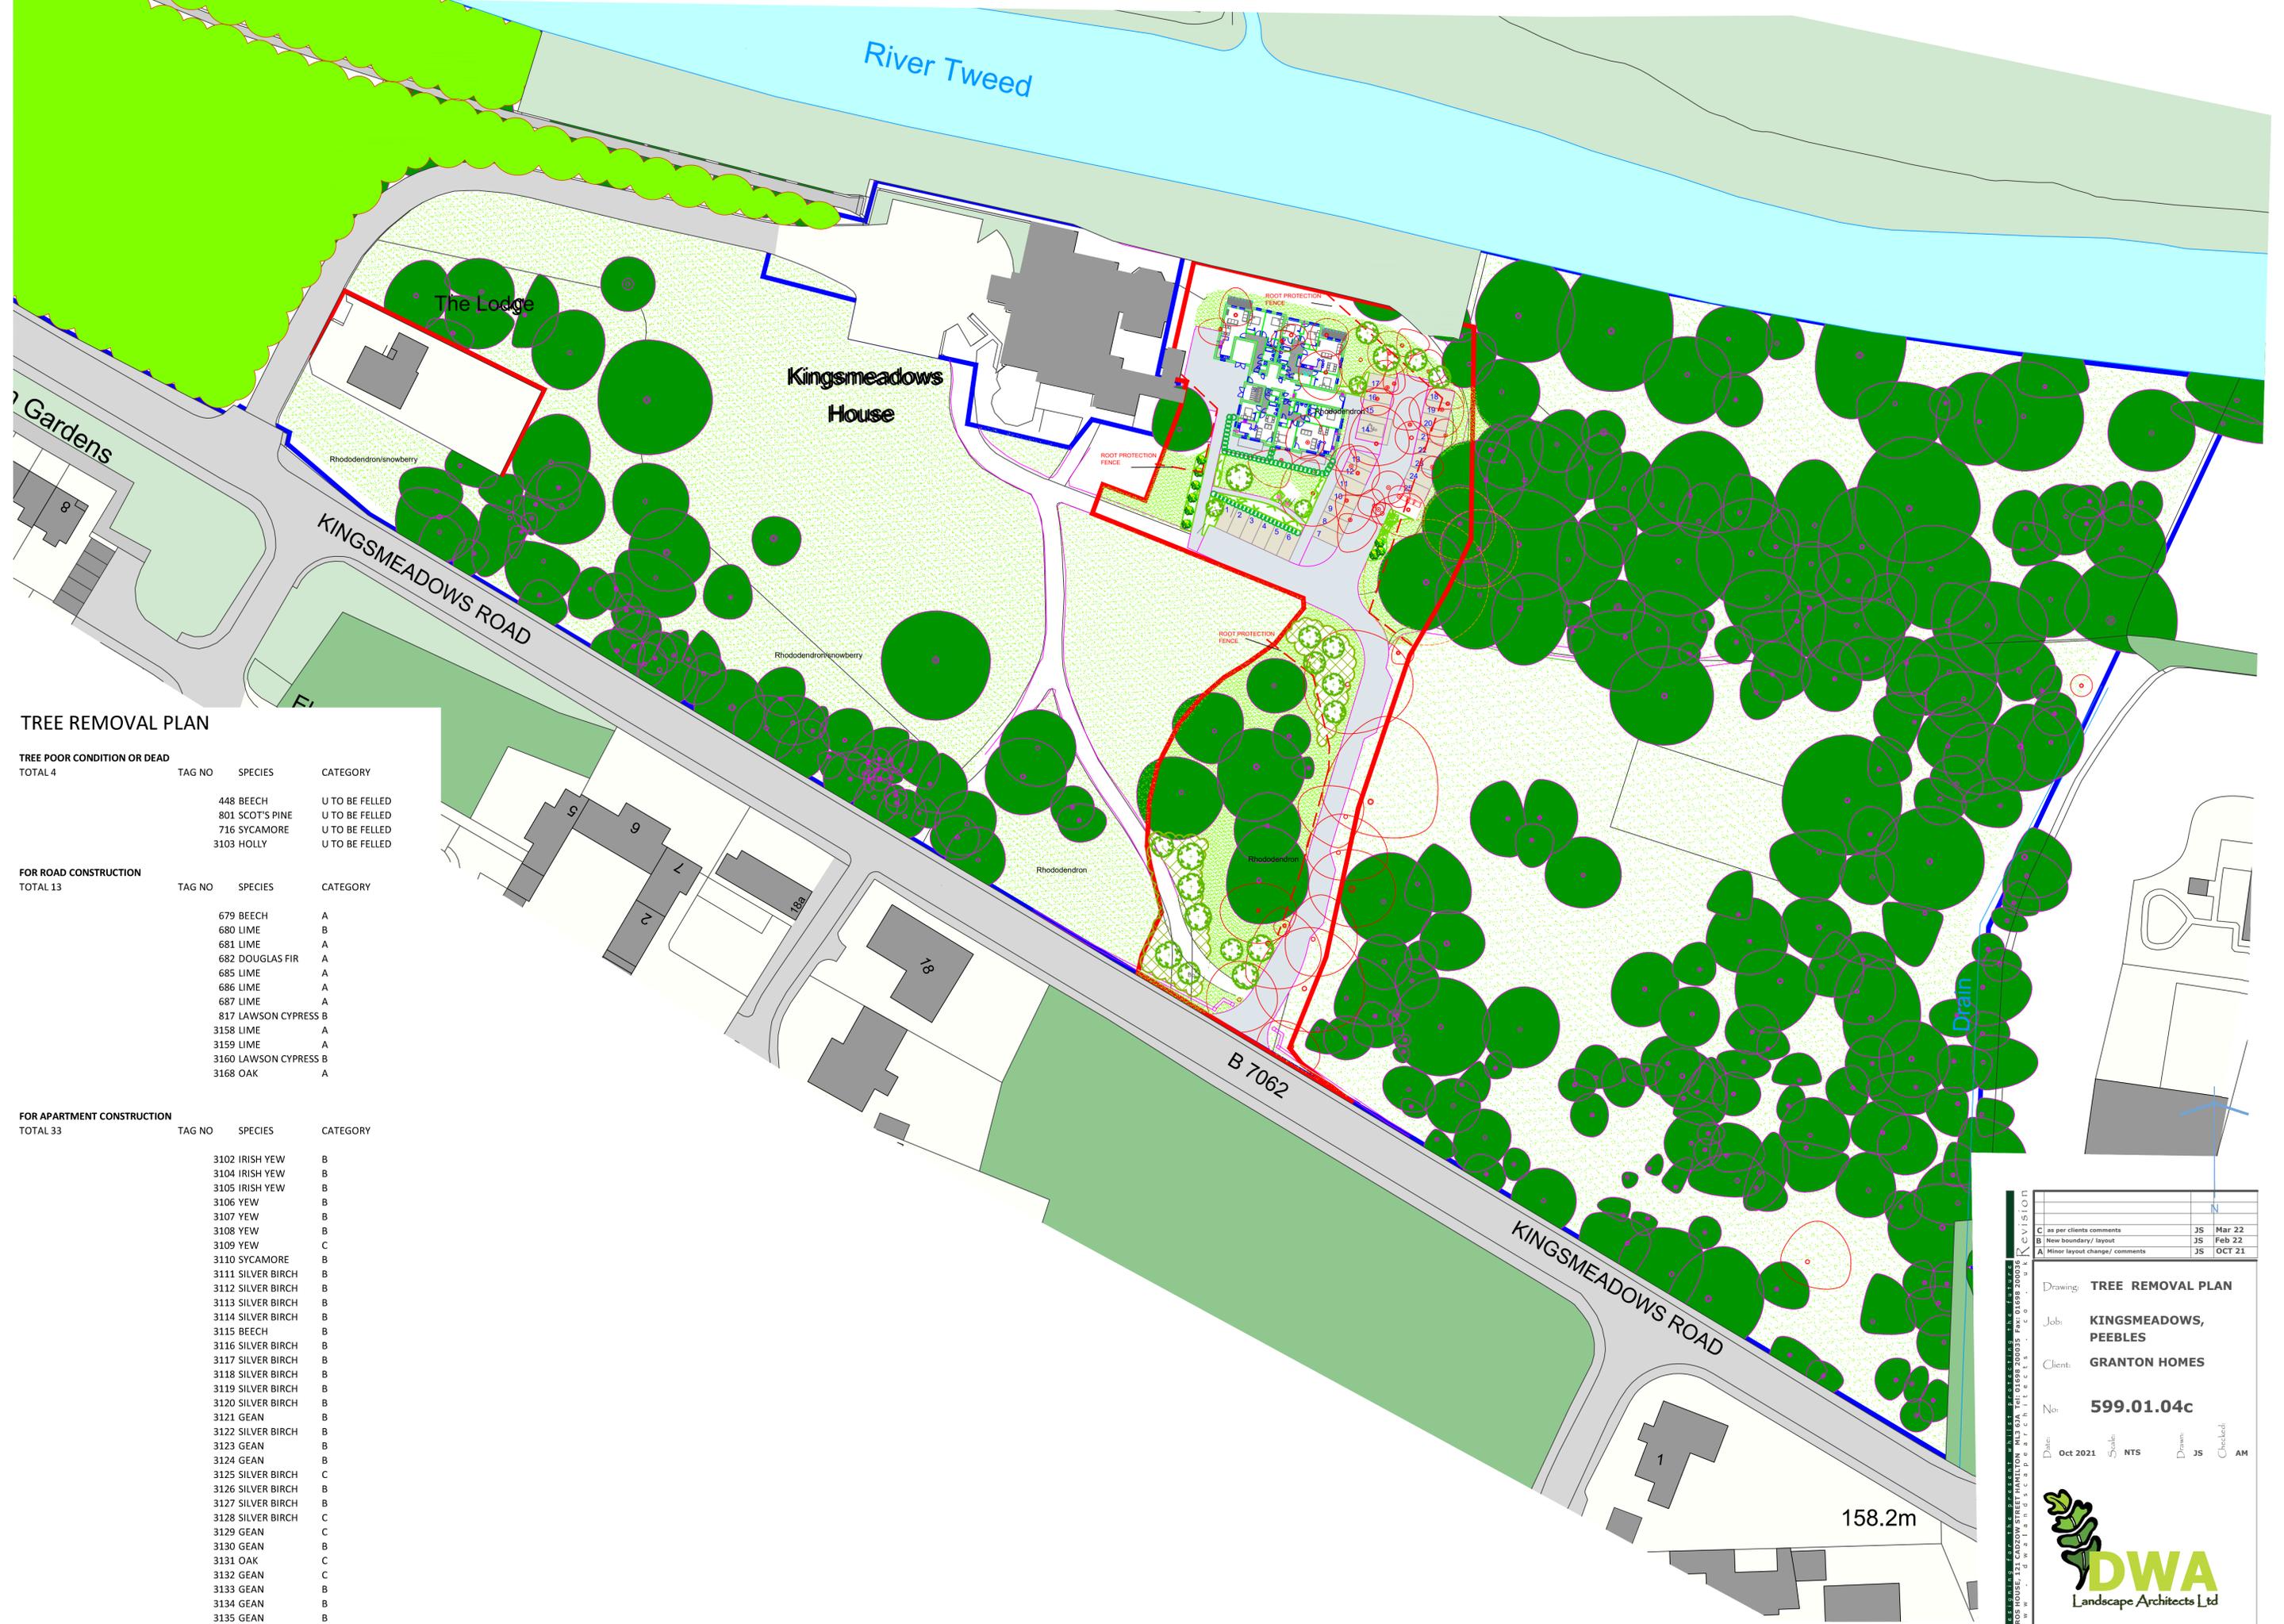
Tree removal plan

- 3.2 The trees to be removed due to condition are as follows:.
- TAG no 716-Sycamore internal decay to be felled and retained as dead wood where appropriate

- TAG no 3103-Holly dead to be felled or kept as standing wood if appropriate
 - TAG no 448 -Red Oak extensive decay to be felled and retained as dead wood where appropriate

TREE POOR CONDITION OR DEAD
TOTAL 4

- Tag no 448- Red Oak, Remove due to extensive trunk damage
- Tag no801– Scots Pine, Remove dead/dying
- Tag no 716 – Sycamore, Remove dead
- Tag no 3103 – Holly, Remove dead
